(NASA-CR-180871) ADVANCED GAS TURBINE (AGT)  
TECHNOLOGY DEVELOPMENT PROJECT, CERAMIC  
COMPONENT DEVELOPMENTS Topical Report, Oct.  
1979 - Jul. 1987 (Standard Oil Engineered  
Materials Co.) 237 p

## Ceramic Component Development

# AGT 101

## Advanced Gas Turbine Program

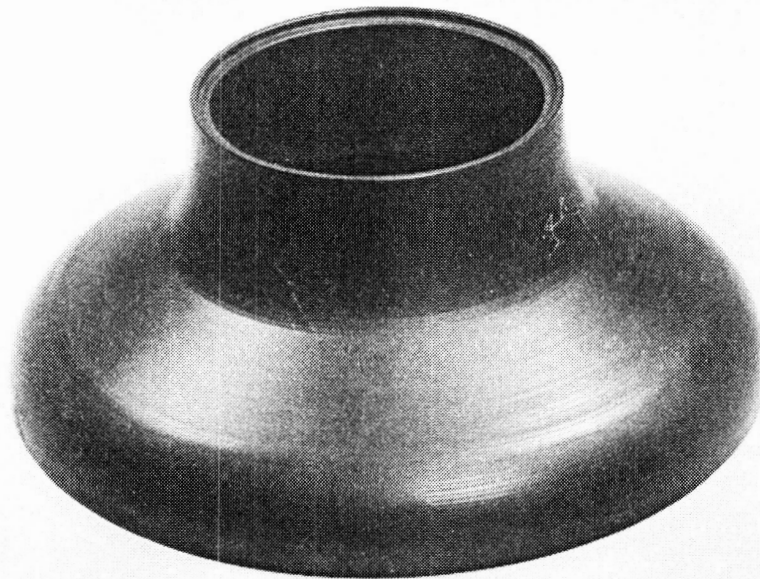
Figure 76. Ground Isopressed Transition Duct

Process development using the contoured isopressing pin continued throughout the second half of 1980. Progress was slowed because of tooling failure and deformation of the aluminum pin. Green machining advances were realized starting in December of 1981 when a CNC lathe became available for machining the I.D./O.D. profiles. Stock was allowed for milling of the tab details. Two units, one ground as shown in Figure 76, the other as fired were completed with some dimensional deviations in January. Both components (101 and 102) were supplied to GAPD for evaluation.

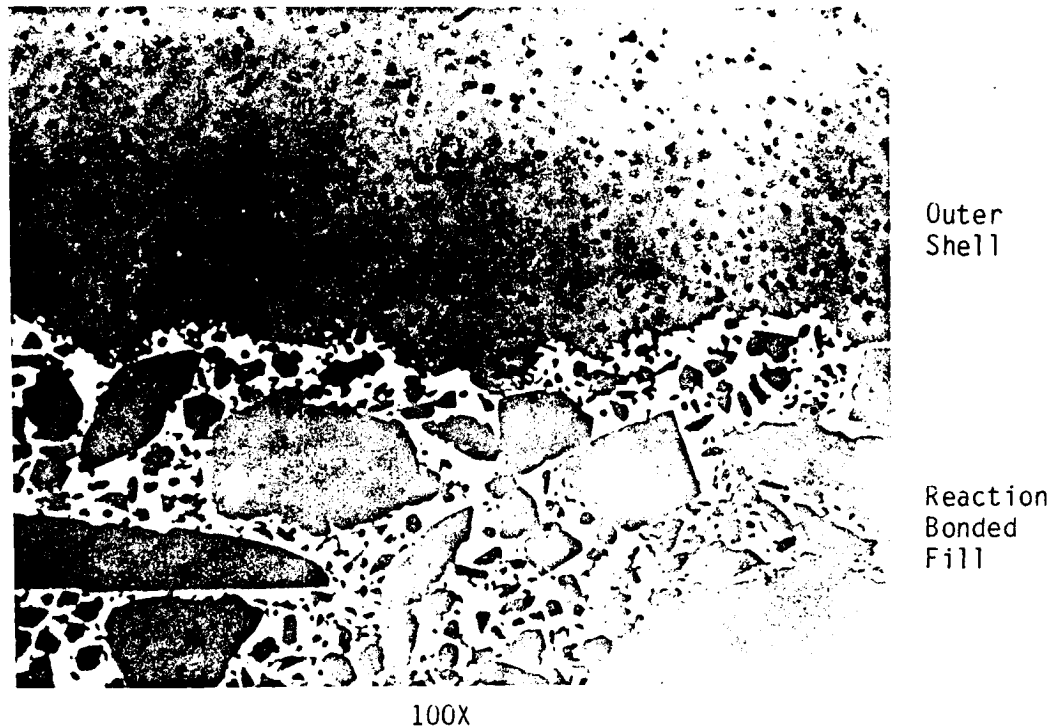
**Fig.105- Microstructural Development Across The Sintered Alpha SiC And Reaction Bonded SiC Interface**

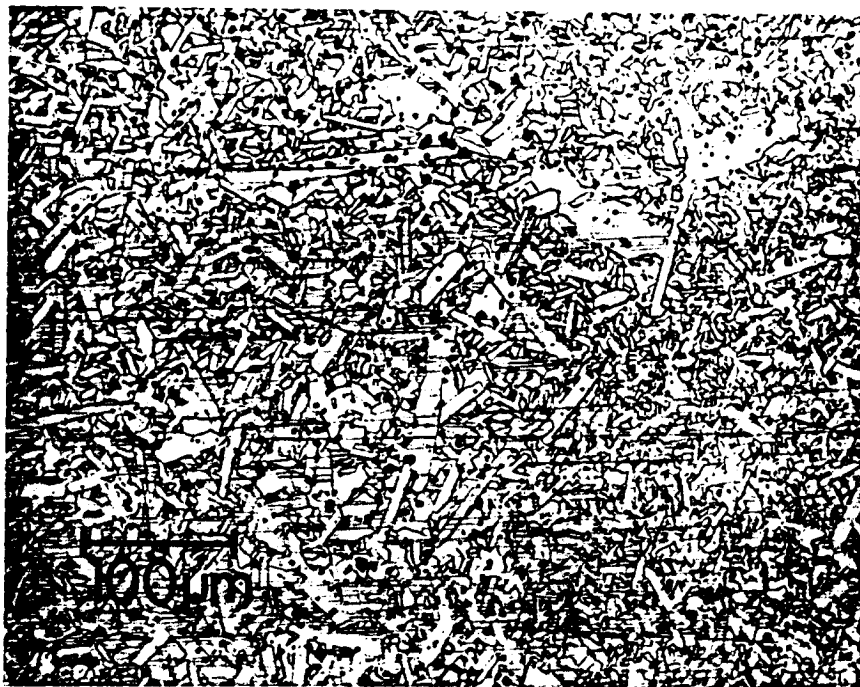
Fig. 113 - No. 80-6. Isopressed SiC Microstructure (Left) and Hot Pressed SiC Microstructure (Right). The Specimen Failed in the Hot Pressed SiC Region.

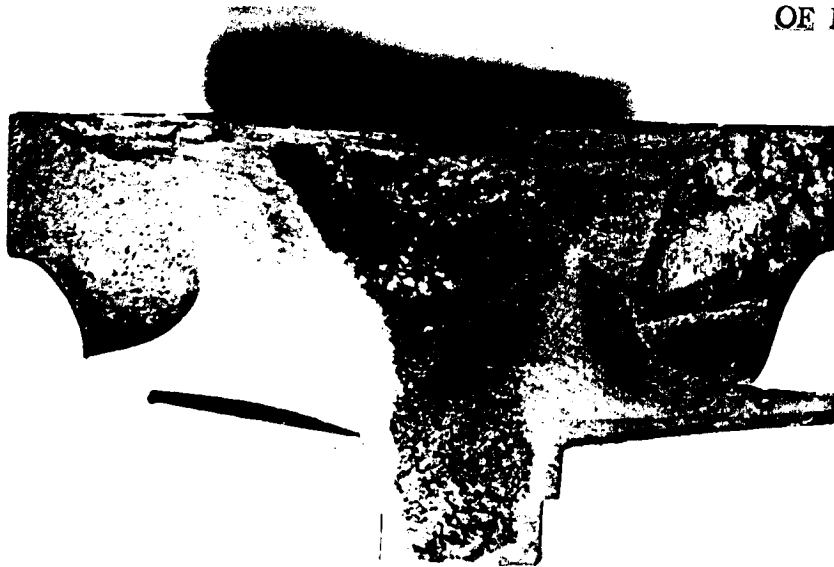
A rotor was cast without difficulty and siliconized in a routine furnace run. A gradual resin bake-out oven run was not used, yet the piece was siliconized without any apparent cracking. The part was diamond wheel sectioned to reveal the interior which is shown in Figure 121. This photograph is life size.

Fig. 121 - Siliconized Coarse Grain Thixotropic RBSiC Rotor

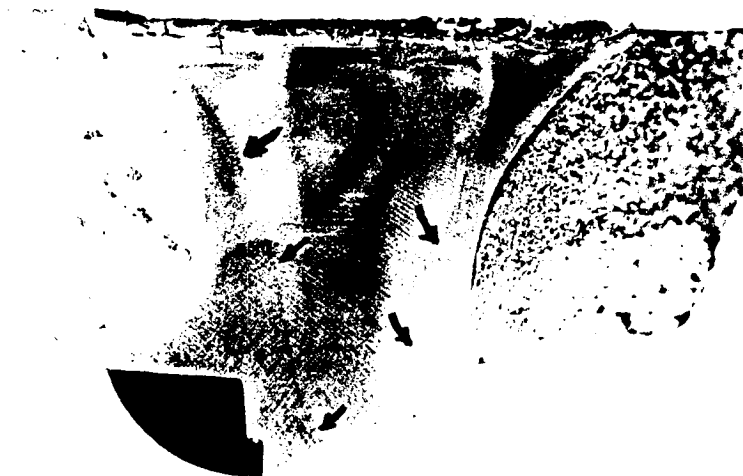
One rotor was siliconized with optimized furnacing conditions in a large production induction furnace with argon atmosphere. This rotor was completely infiltrated with silicon (Figure 126). There are apparently two regions: an outer layer approximately 1/8- to 1/4-inch thick which has a large amount of free silicon, and a central zone with less free silicon in the microstructure. This variation occurs because the furnace does not have good atmosphere control and even though the furnace is purged with inert gas, some air leakage occurs. The oxygen oxidizes the surface of the rotor and removes carbon. When the rotor is silicon infiltrated, there is no new silicon carbide formed at the surface from a silicon-carbon reaction. Thus the outer zone has a higher free silicon amount. Further attempts eliminated this effect. The induction furnace with argon thus demonstrated that thick sections of fine grain material can be siliconized.

Fig.126 - Cross Section of A Thixotropic Cast Induction  
Furnace Siliconized RBSiC Rotor

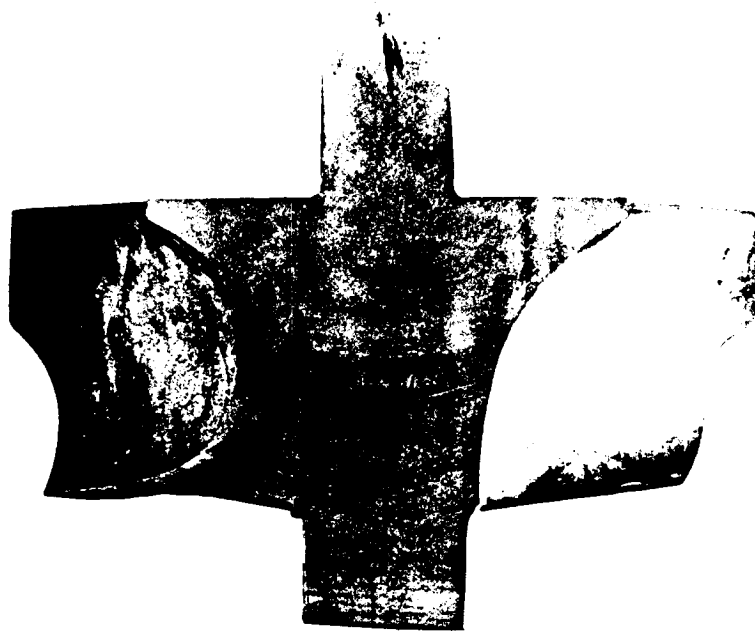
With the second piece (Figure 127), care was taken to thoroughly clean the joining surfaces, and a finer particle size mix was used as a filler. With the exception of small casting voids near the surface of the hub, this part looked good, with complete siliconization and joining of shaft and rotor (Figures 128 and 129).

Fig.127 - RBSiC Thixotropic Cast Rotor Sliced to Show Shaft  
Attachment and Complete Siliconization

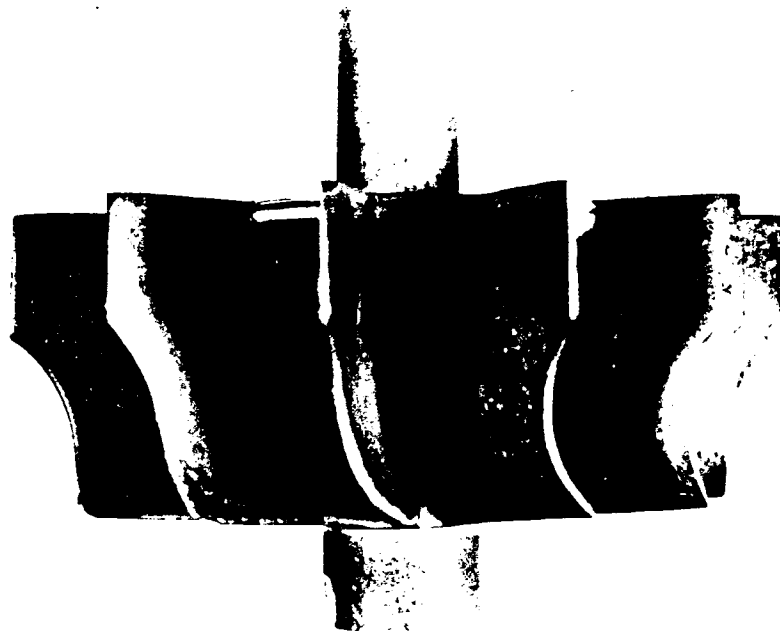
**Fig.128 - Fired RBSiC Thixotropic Cast Rotor With Shaft Attached**

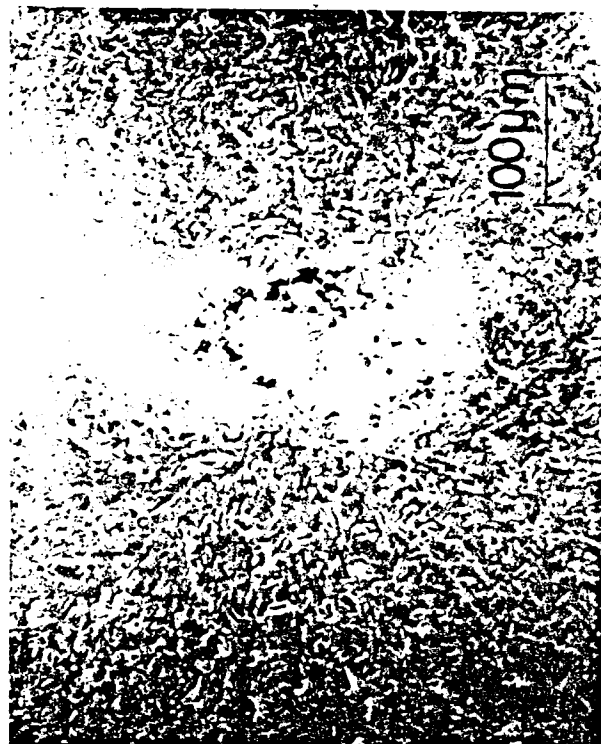
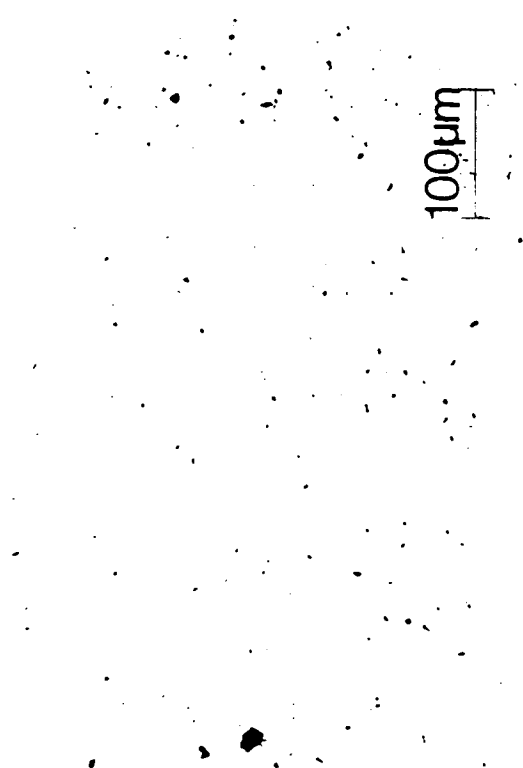
In Figure 131, the microstructure and failure origin for injection molded and sintered alpha silicon carbide are shown for a control specimen. The unetched microstructure shows micropores which are located primarily at grain boundary triple points as revealed in the etched microstructure. The failure origin for this specimen which failed at 60,700 psi is a processing-related unbonded SiC inclusion. In addition to this flaw type, voids in the range of 70 to 200  $\mu\text{m}$  were also seen to be failure causing in many other specimens. No machining was performed for these control specimens and also all CVD coatings were deposited on the as-fired surfaces of injection molded and sintered alpha silicon carbide. In Figure 132, the nature of the coatings is examined via optical and scanning electron microscopy for MTC-coated specimens. The cauliflower-like appearance of the deposit indicates the size of individual grains. Good adhesion is evident with the absence of micropores in CVD SiC compared to sintered silicon carbide. The columnar growth of  $\beta$ -SiC grains during the CVD process can also be seen in one of the figures. MTC samples appeared to have the

Etched Microstructure

Internal processing-related unbonded inclusion

Unetched Microstructure

Fig. 131 - Microstructures and Failure Origins for Injection Molded SiC Specimen Used as

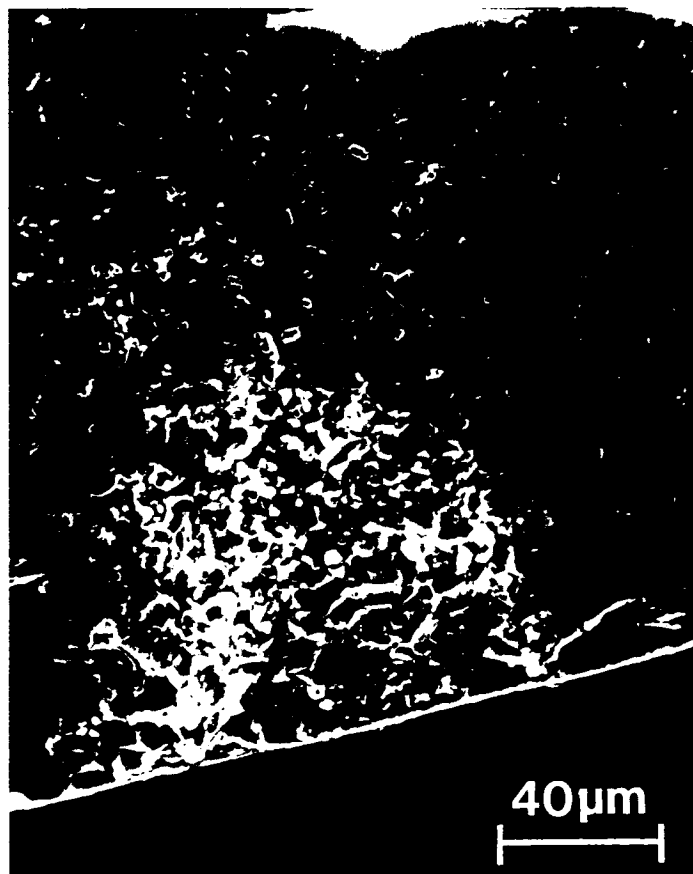
Fig. 162 - Failure Origin for No. 4-11. Failed at 1300°C After 17.7 h. Survived 24 hours successively at 800°C through 1200°C at 100°C Intervals

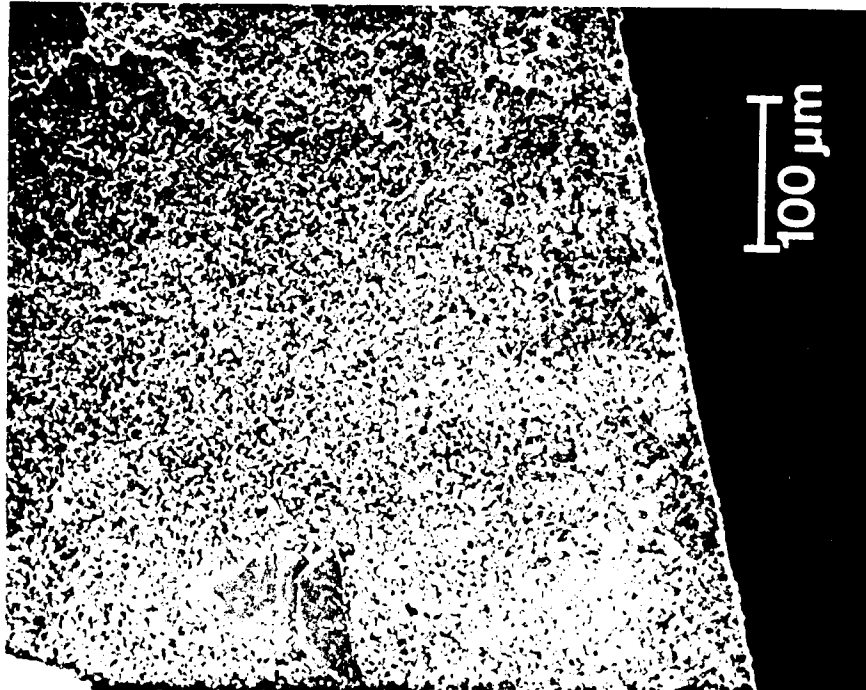
appearance of another specimen (Figure 166) is very different. Here again, no obvious slow crack growth region exists although the fracture surface contains contaminants. This specimen failed in 36 minutes at an applied stress of 57,000 psi.

(b)  
SEM Fracture Surface Appearance

Fig. 166 - Microscopy Results for a Specimen Subjected to Stress Rupture Test at  
1200°C (2192°F) at an Applied Stress of 57,000 psi - No. 106-6

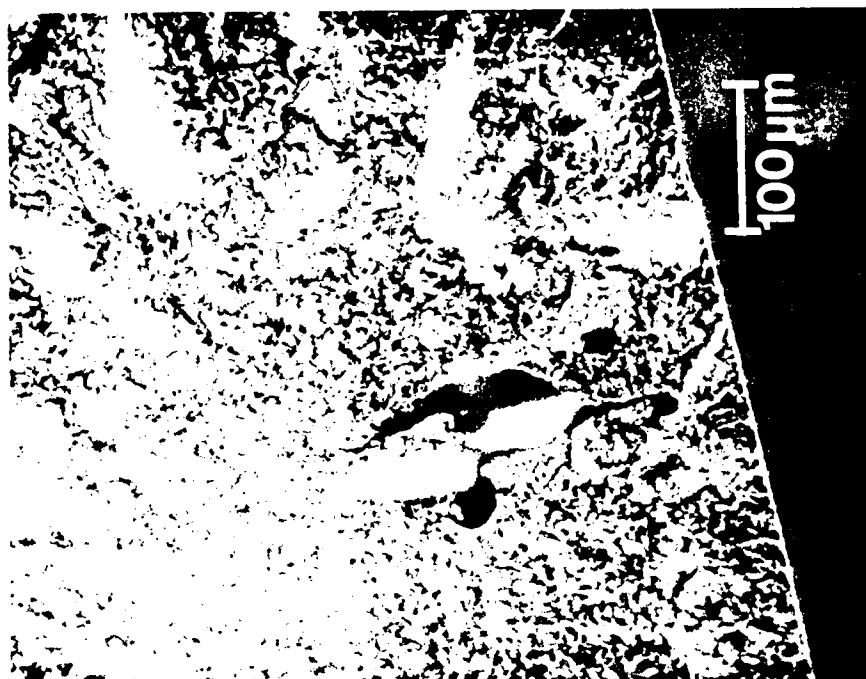
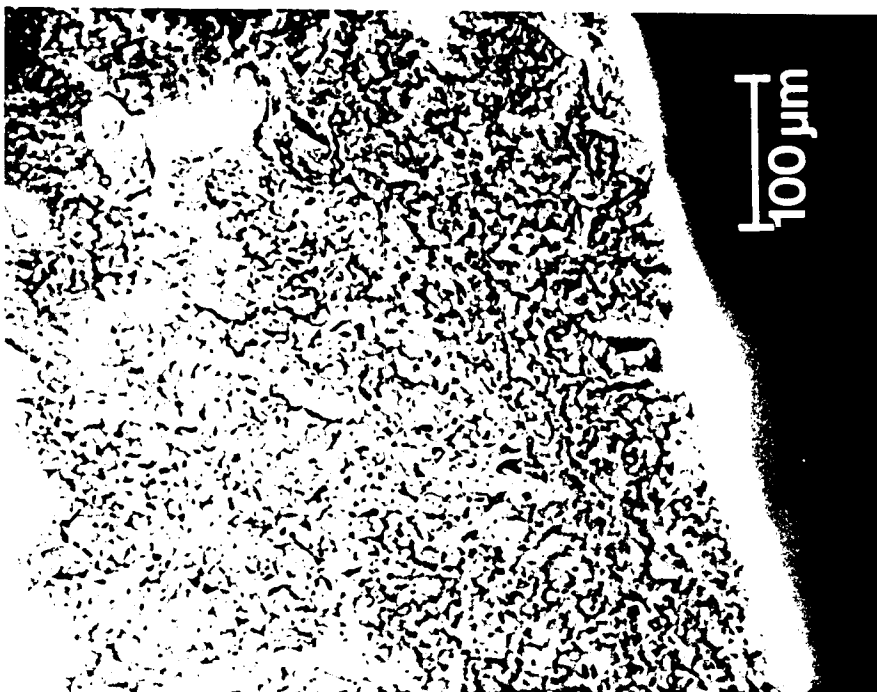
A SEM failure analysis was conducted on failed specimens. Two examples of fracture surface appearance are shown in Figure 168. In both instances, processing-related crack-like voids caused fracture. Although 40-60 hours expires in the test, no oxidation-related slow crack growth region around the main flaw can be seen.

(a)  
No. D-9.  $\sigma_a = 45,000$  psi;  $L_f = 65.5$  h

(b)  
No. H-4.  $\sigma_a = 50,000$  psi;  $L_f = 41.5$  h

Fig.168 - SEM Results for Sintered Alpha SiC Specimens Subjected  
To Stress Rupture Test at  $1500^{\circ}\text{C}$  ( $2732^{\circ}\text{F}$ )
